## **Evaluation of High Pressure Flushing Test SVB-Nr. 06.18082 S**

**Test of resistance of liner type "FlexiLiner II Plus" to flushing  
by high pressure cleaning device acc. to the "Hamburg model"**

client: **KRT Kanalsanierungs-Technik AG**  
**Luzernerstr. 19**  
**CH 6204 Sempach**

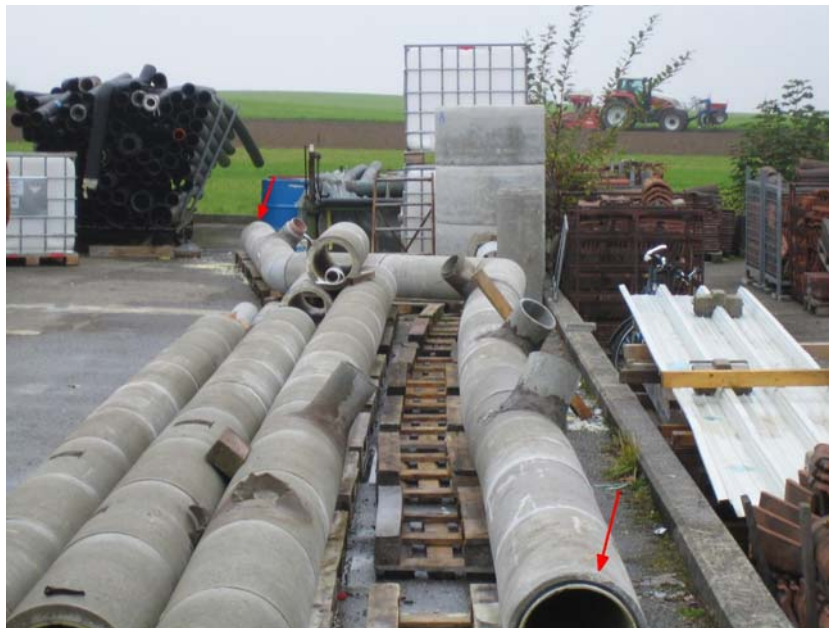
Illus. 1

The test pipe is a DN 300 concrete sewer pipe that is about 18 m long. For the test of the said inliner system it was partially repaired. According to the company KRT Kanalsanierungs-Technik AG the installed cured-in-place pipes are a liner system made up of epoxy resin and polyester needle felt (synthetic fibre) named "FlexiLiner II Plus". The impregnation log and the heating log were presented. There is no approval by DIBt, the German Institute of Construction Engineering.

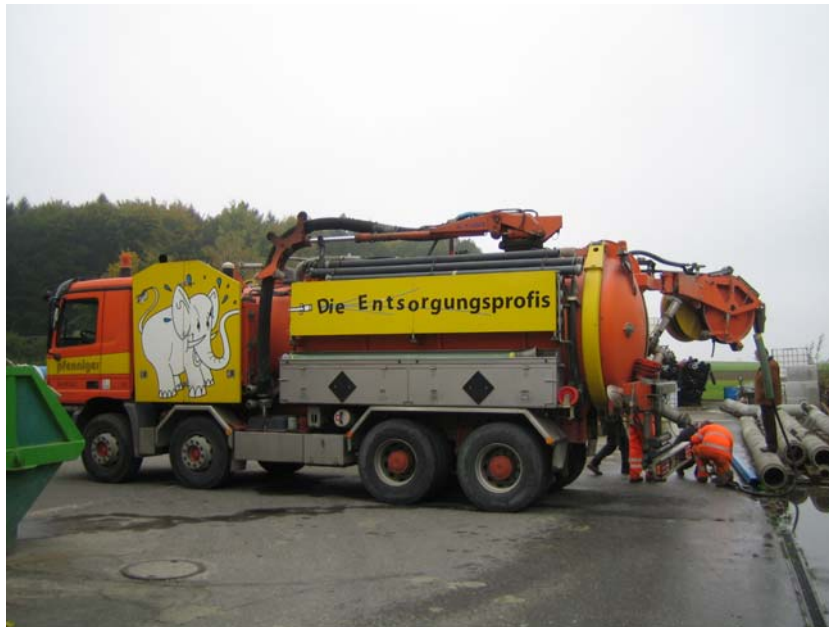
Illus. 2

water pressure at the vehicle	190 bar
volume flow	~320 l/min
hose length	190 m
hose diameter	1 inch

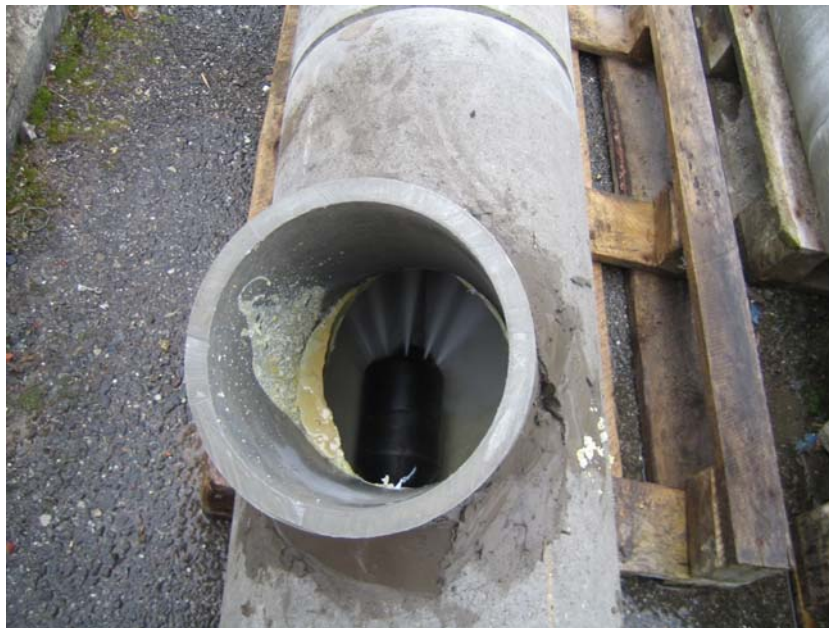
Illus. 3

number of jets	10 pieces
jet diameter	2.3 mm
jet angle	30°
volume flow at 120 bar	about 320 l/min
pressure on the jet	about 120 bar

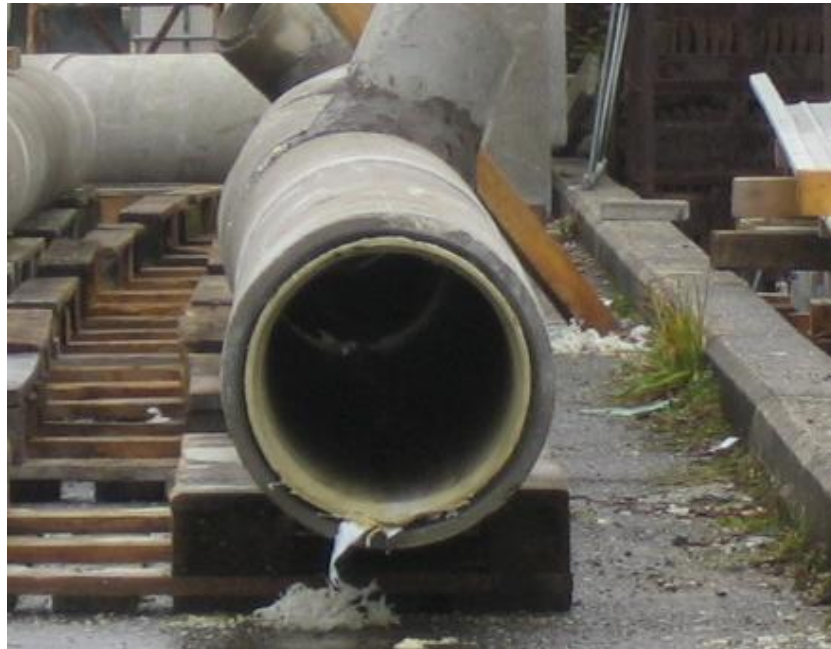
Illus. 4

The system "FlexiLiner II Plus" is a combination of a cold-curing epoxy resin and a polyester needle felt. The synthetic fibre has no static function and just serves as a resin carrier fibre. On the one hand the resin matrix is the static, load-bearing component, on the other hand it is a sealing system preventing exfiltration and infiltration. All films and foils just facilitate work and installation, and when the curing reaction is complete they have no further function. The liner thickness is determined in advance based on the static requirements. In this case it is 6mm for a diameter of DN 300.

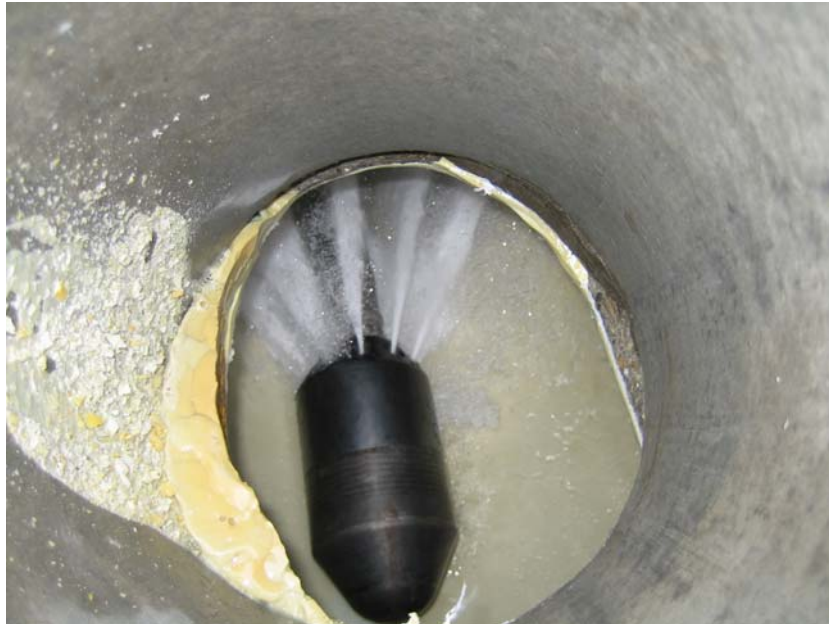
Illus. 5

A 21 m length of DN 300 concrete pipe was built on the premises of KRT. Four DN 150 branches and two 45° bends with diameter DN 300 were installed. Two branches were on the springing line, the other two were in the pipe apex area. A cured-in-place pipe was installed in this test pipe section. The liner thickness was 6mm. When the liner had cured the side branched were cut out by a milling robot. Hat profiles were not used. In addition to the 30 flushing cycles a total of three spot flushing tests over three minutes each were done.

All flushing was done from the main pipe.

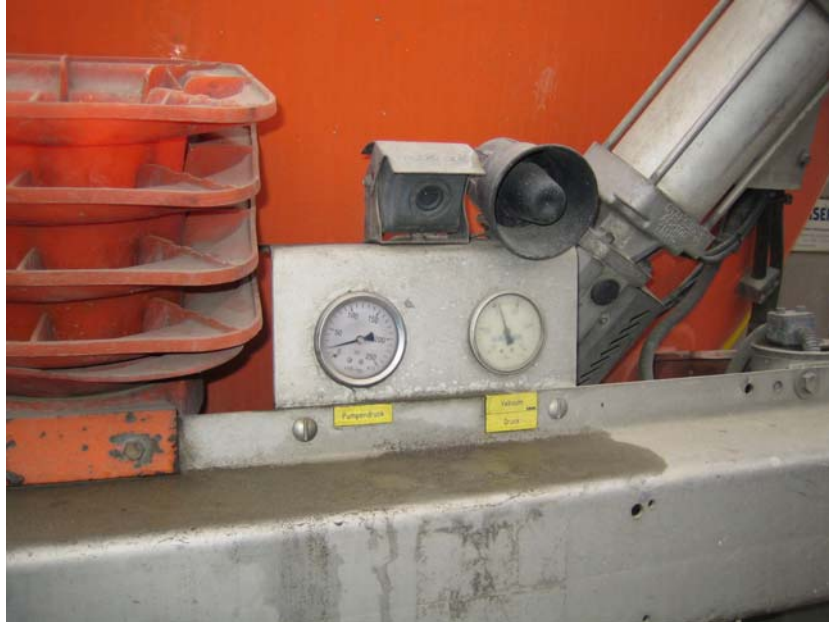
Illus. 6

The volume flow at 120 bar was specified as 320 l/min. In order to identify the 120 bar flushing pressure at the flushing head we determined the pressure drop in the hose. The flushing pressure reading at the vehicle was 190 bar. So the actual pressure at the flushing head, taking the pressure drop into account, was 120 bar.
