2.2.11 Primo Robot System

Procedure

Procedure Category *Maintenance / Repair Procedures*

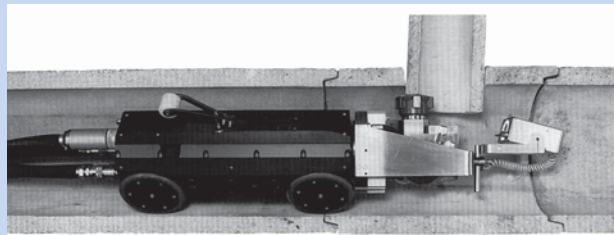
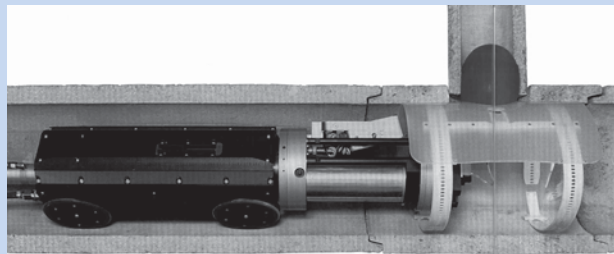
Schematic diagram

Brief description *The robots are put into the pipe section via an inspection shaft and guided to the damage site by an operator in the control vehicle using the remote camera. The damage is repaired by means of various devices capable of carrying out a variety of tasks such as grinding, drilling, injecting, filling and smoothing and sanding. The placing of rubber seals for the repair of lateral connections is also possible.*
