2.2.42 PE Short Pipe Relining System

Renovation/Relining Procedure

KRT Engineering + Handel GmbH, Sempach

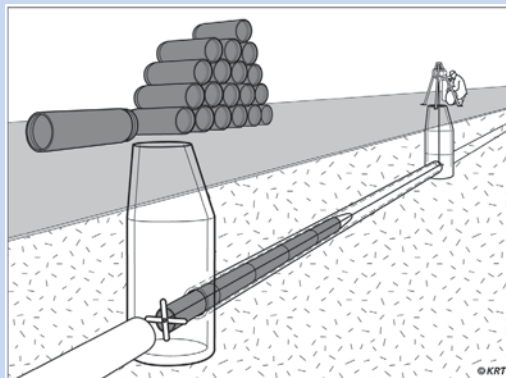
Schematic Diagram

Short sleeve jointed HDPE pipes are inserted or drawn into the existing pipe-work via an inspection shaft. Individual short pipes are assembled in the inspection shaft and are either inserted, bolted or welded together. The ends are secured into the shafts (by packing or anchor points) and the annular gap between old and new piping must be plugged. To secure the joints, the section of the pipe in question must remain uncovered.
